Top 10 Mini Problems

Dr Minimag diagnoses the most common Mini ailments ... and tells you how to fix them.

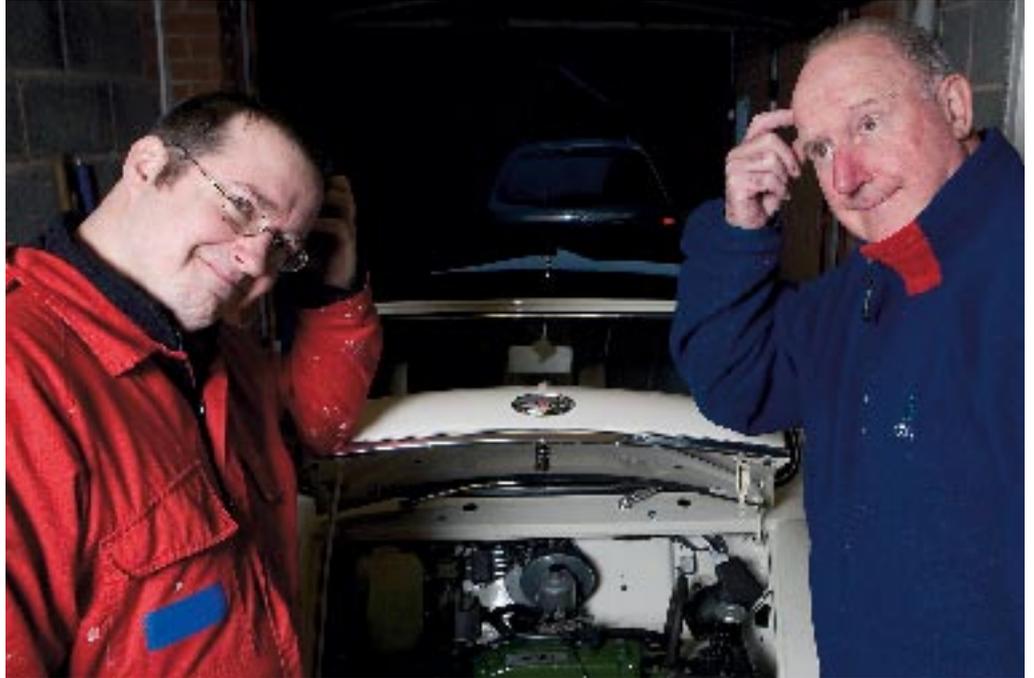
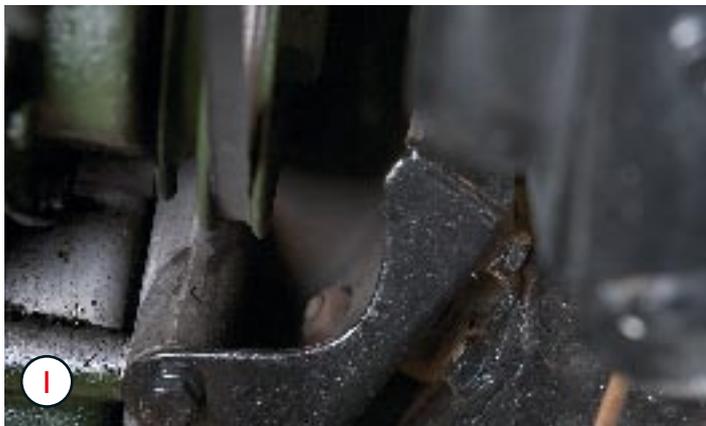
Symptoms: Knocking noise during engine acceleration/deceleration

Diagnosis: Deteriorated engine steady mounts

The A-Series engine on a Mini is held in with two main engine mounts and one or two steady bars made of a combination of rubber and metal. In the case of the main engine mounts, this is two pieces of metal sandwiching a rubber block. Over the course of time the rubber gets affected by heat, oil and fluid and shaken by the power of the engine. If the rubber breaks up it allows movement in the mounts, causing a knocking or clicking noise when you press the accelerator down in gear or lift off. This noise is the engine moving backwards and forwards, and the only way to remedy this is by fitting new mounts.

To do this you need to remove the steady bars, release the first section of exhaust and, if you are replacing the mount on the driver's side, take out the top radiator bracket. Support the weight of the engine with a jack and undo the mounting bolts on the subframe, then slowly raise the engine until you have enough clearance to access the bolts. You may find, however, that removing the clutch cover is easier than trying to get to the bolts or the subframe. To do this, remove all the bolts around the outer edge then pull out the plunger for the clutch slave cylinder.

Refitting is the reverse of removal. New mounts are available that have a captive nut built into them, making fitting the subframe bolts back in again easier.

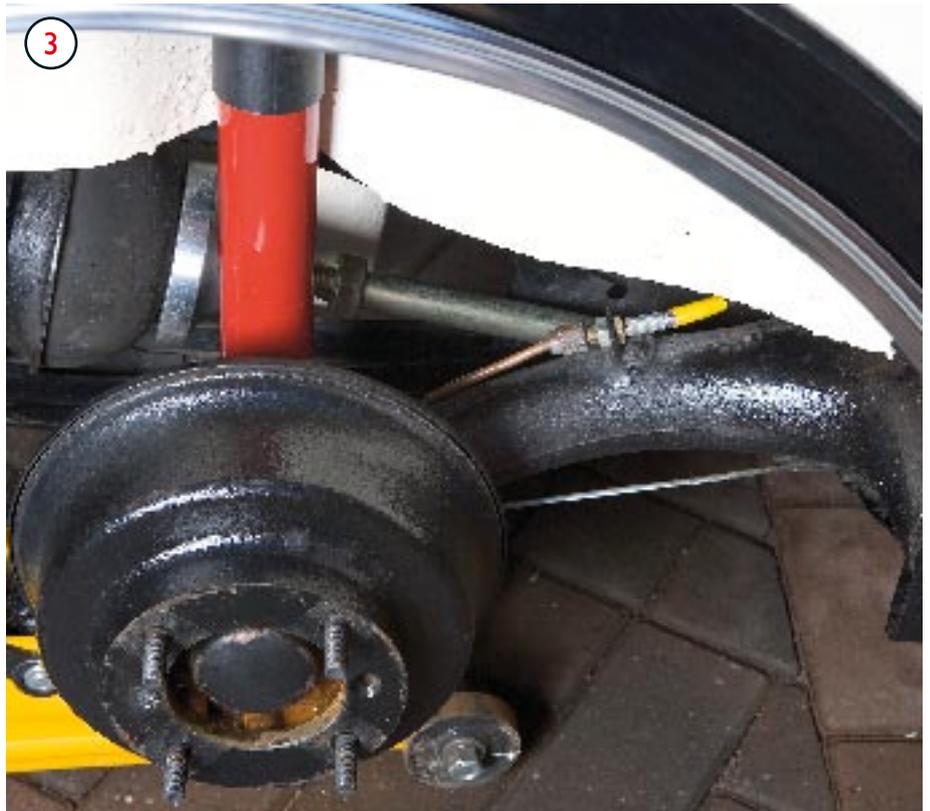
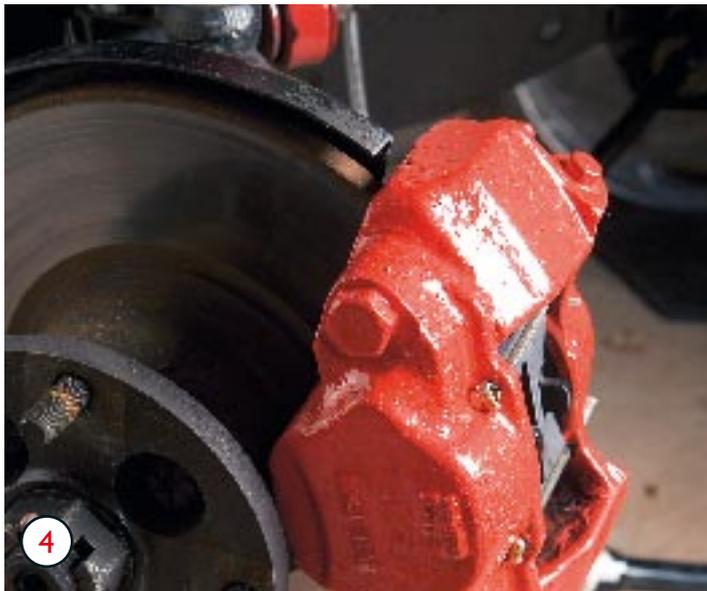
Symptoms: Car pulling to one side when braking

Diagnosis: Brake dust build-up

The front brakes rely on the four pads making contact with the brake disc at roughly the same time. If the car veers to one side when you brake the likely cause is a pad not reaching the disc at the same time as the rest, which could be due to a build up of brake dust on the pistons of the calliper or where the pads go. This may be cured by simply removing the pads, cleaning the calliper and refitting the pads again, but if the calliper pistons are damaged then the complete calliper will have to be replaced.

Jack the car up, remove the wheel and the split pins that hold the brake pads in, then take out the brake pads. Note which pad goes on which side of the calliper, as it will already be bedded into the brake disc. Also check the amount of friction material that's left on the pad and, if it's low, replace the pads. Using a brake cleaner, spray clean all around the calliper and piston area and use a small wire brush — avoiding going near the piston seals — to remove the build up of brake dust. When refitting the brake pads, add a small amount of copper grease to the back of the pads to eliminate any squeal. Refit the split pins and wheel, remembering to pump the brake pedal back up before you drive off.

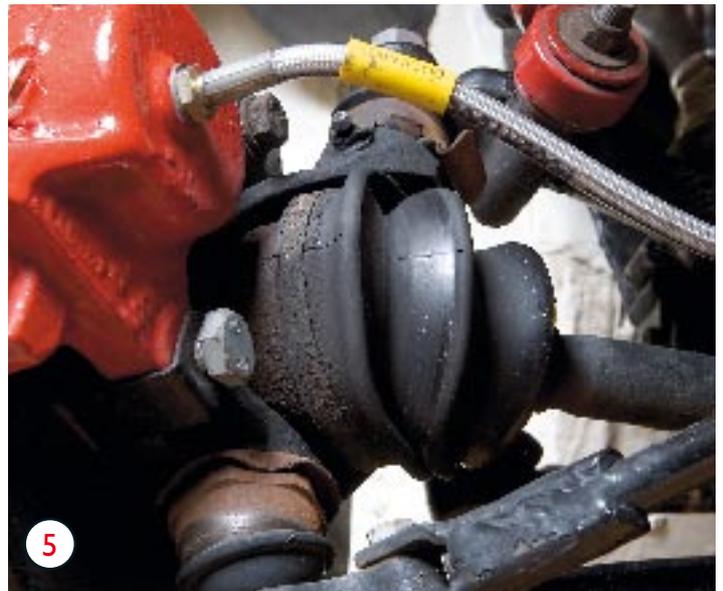
Symptoms: Knocking noise from the front with the steering on lock

Diagnosis: Worn CV joint bearings

Part of the Mini's design, way back before it was born, was the creation of the constant velocity (or CV) joint. This enabled the transmission of power through the front wheels while still being able to turn them, thanks to a combination of ball bearings in cages which allow the joint to turn. When these ball bearings wear there is increased play in the joint, creating a knocking noise as the components of the joint come into contact with each other.

Replacement of the CV joint bearings involves jacking the car up, then removing the wheel and the hub nut in the centre. The top balljoint needs to be split from the upper arm and the CV boot pulled back from the joint. Knock the joint off the shaft, making sure you locate and retain the clip that goes on the end of the driveshaft. Refitting is the reverse of removal, making sure that the hub nut is tightened up to the correct torque and then tightened up further, until the hole lines up with the castle nut and you can put the pin in again.

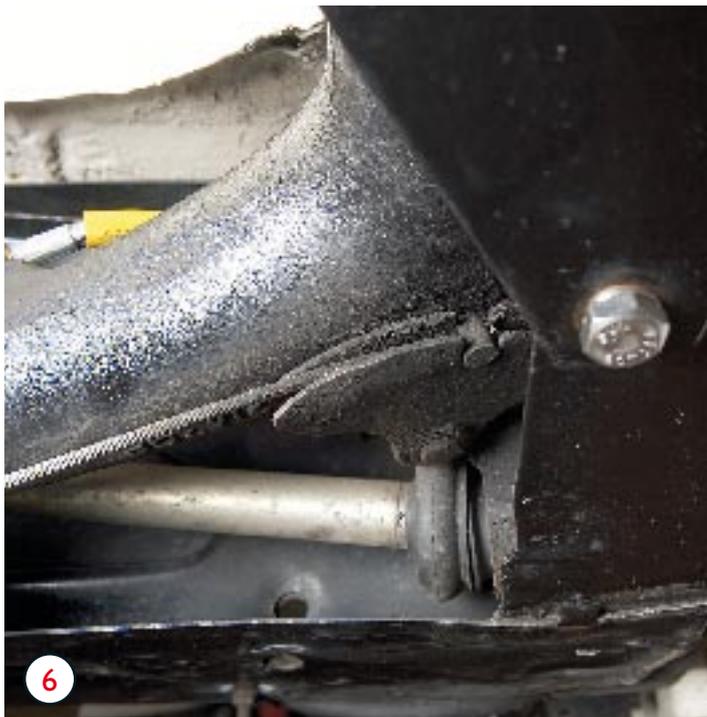
Symptom: Handbrake not holding
Diagnosis: Seized handbrake cable

The handbrake is one of the least efficient items on a Mini, but it's important to be able to park your Mini on a hill and come back to find it where you left it! There are two areas that need looking at: the brake unit and the cable. The former is adjusted by turning the adjusting screw in clockwise — as viewed from looking at the back plate — until the drum locks up, then backing off two notches (or until the drum moves freely again). The brake cable is operated by a bracket on the centre of the rear subframe, which should be well greased, and two moving quadrants, one on each of the radius arms. These need to moving freely to allow the cable to be pulled backwards and forwards, which isn't helped by all the muck from the road. Free up and grease these if they're seized. Finally, adjust the cable from the inside of the car on the back of the handbrake lever to give four or give clicks before the brakes hold.

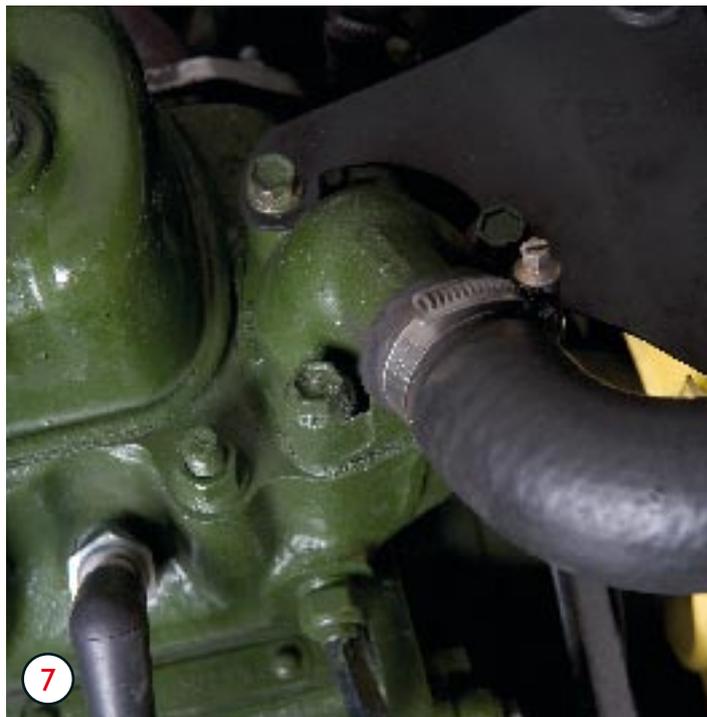
Symptom: Engine not getting warm, or getting too hot
Diagnosis: Thermostat stuck open

A thermostat in the top of the cylinder head governs the flow of coolant through the engine. If this gets stuck open then the engine won't warm up correctly or may take a long time to do so, but if it doesn't open at all then the coolant won't flow and the engine will overheat. Replacing the thermostat is very simple: take out the top hose between the thermostat housing and the radiator, then the radiator top mount, then undo the three bolts or nuts and remove the thermostat housing.

Don't be tempted to just remove the thermostat if your engine is overheating: this will cause stagnation of water in and around number four bore and may damage your engine internally. Fit a new thermostat, replace the housing, radiator bracket and top hose, then top back up the coolant and run the engine until it's hot to eliminate any air from the system before refitting the radiator cap.

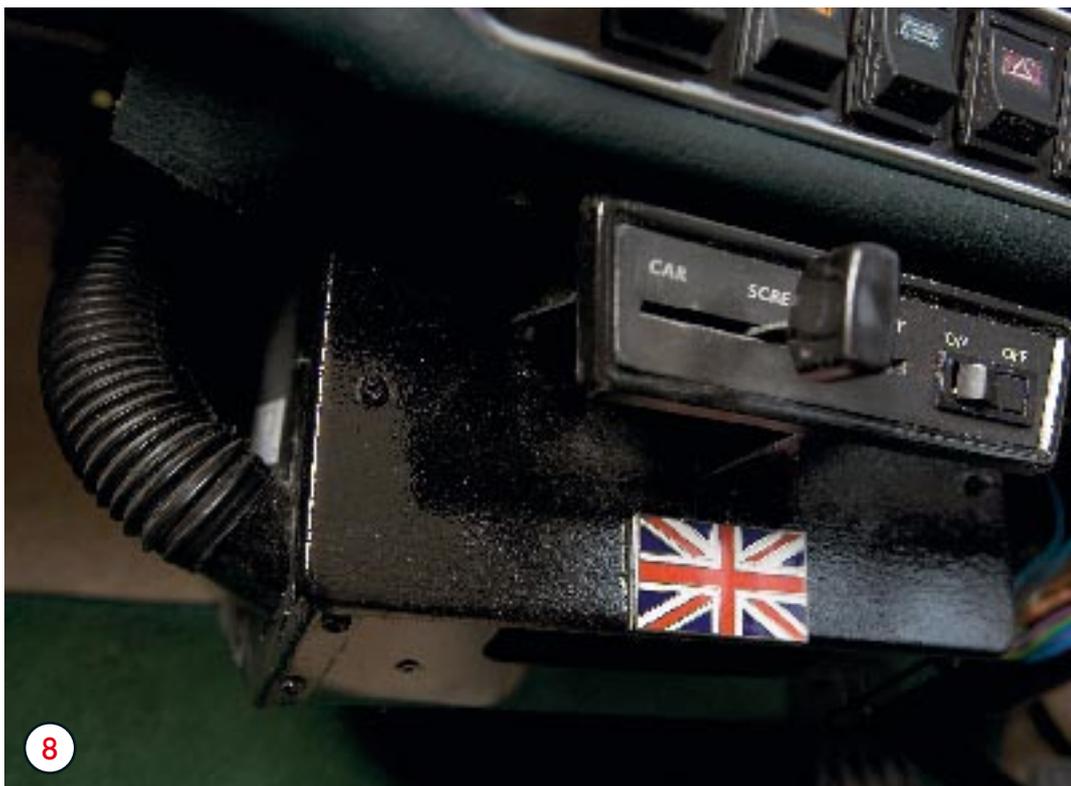
Symptom: Water leak from the heater box
Diagnosis:

Leaking heater matrix
 If the screen steams up when you direct the air from the heater to it or if you have a wet carpet but can't work out where the water is coming from, it's likely that the heater matrix is leaking. To replace it, remove the heater box from the car by draining the coolant system — the best place is from the bottom hose in the engine bay — and removing the heater pipes from the side of the heater box.

Then undo the two screws that hold the heater box to the lower dash rail, disconnect the electrical connection and unhook it from the bulkhead. Change the heater matrix, then refit the heater box (simply the reverse of fitting it) with the addition of bleeding the coolant system.

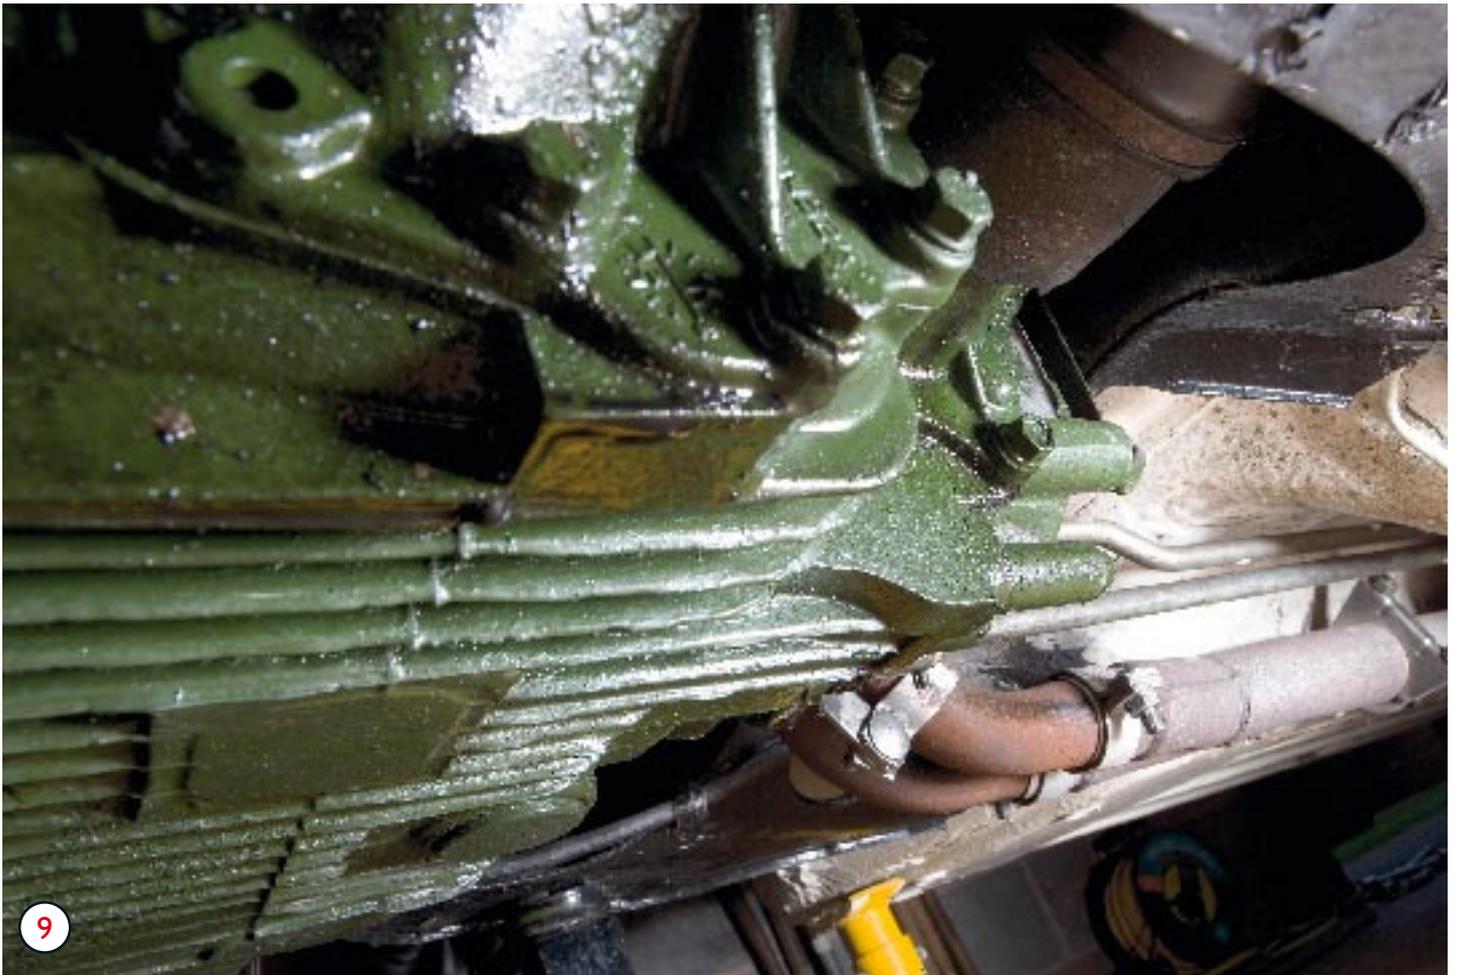
Symptom: Oil leak when parked up

Diagnosis: Perished oil seals

Although there are numerous places that leak oil, some cause more problems than others. The gear selector oil seal and the driveshaft oil seals can be particularly difficult. In both cases, drain the engine of oil first. The gear selector oil seal is fairly simple and involves removing the roll pin from the selector, hooking out the oil seal with a screwdriver and refitting the roll pin.

The driveshaft oil seals are trickier. Remove the wheel and split the top balljoint from the upper suspension arm, then remove the inner pot joint from the gearbox (either with the correct tool or a long lever). Extract the oil seal housings from the side of the gearbox and fit a new seal into the housing. Refit the pot joint back into the gearbox, being careful not to damage the new seal, and bolt the balljoint back onto the upper arm again. Finally, refill the engine with oil.

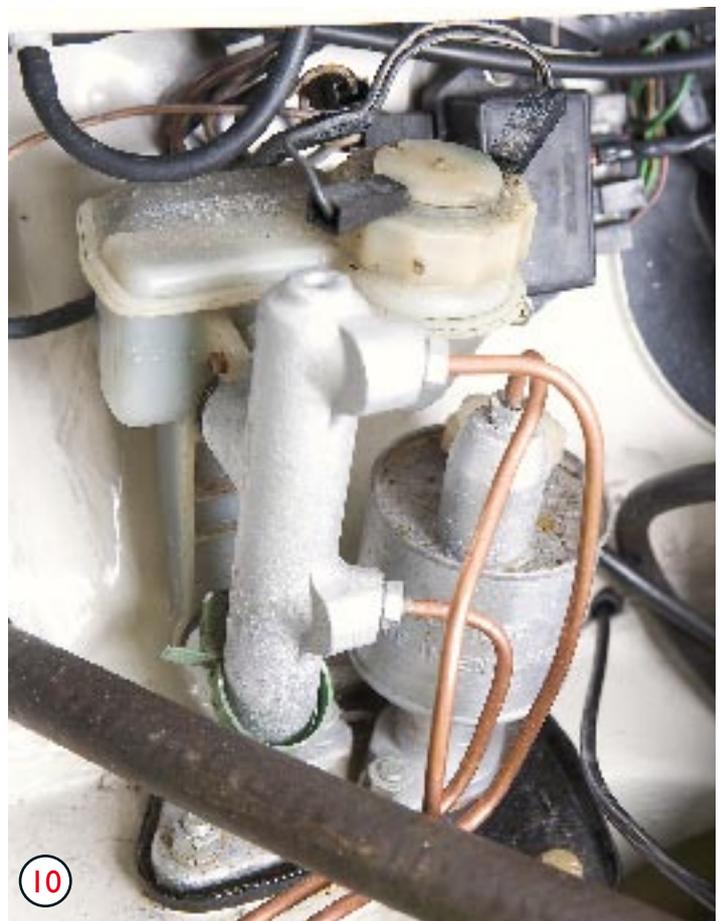
Symptom: Clutch not disengaging

Diagnosis: Fluid leak in the system

The clutch on a Mini is controlled by two devices. The master cylinder operates off the brake pedal, pushing fluid via a pipe to a cylinder that moves the clutch arm and releases the clutch. If there is a leak in any part of the system then the full clutch releasing action won't happen. If you see fluid running down the pedal then the master cylinder may be leaking, and fluid around the slave cylinder means that could be leaking.

Replace the master cylinder by undoing the split pin and clevis pin that hold it to the brake pedal, then removing the pipe from the top of the master cylinder and unbolting it from the bulkhead. The slave cylinder is changed by removing the flexi hose from it then unbolting it from the bracket on the engine. Refitting on both is the reverse of removal, but don't forget to refill the system with fluid and bleed the air out of it.
