# A GENTLEMAN'S GUIDE TO *CLASSIC* SMITHS ELECTRONIC TACHOMETERS

**TRIUMPH OWNERS' CLUB**  
**CHRISTCHURCH**  
**NEW ZEALAND**

**Author: Alex Miller**  
**Email: [lxmiller@kinect.co.nz](mailto:lxmiller@kinect.co.nz)**

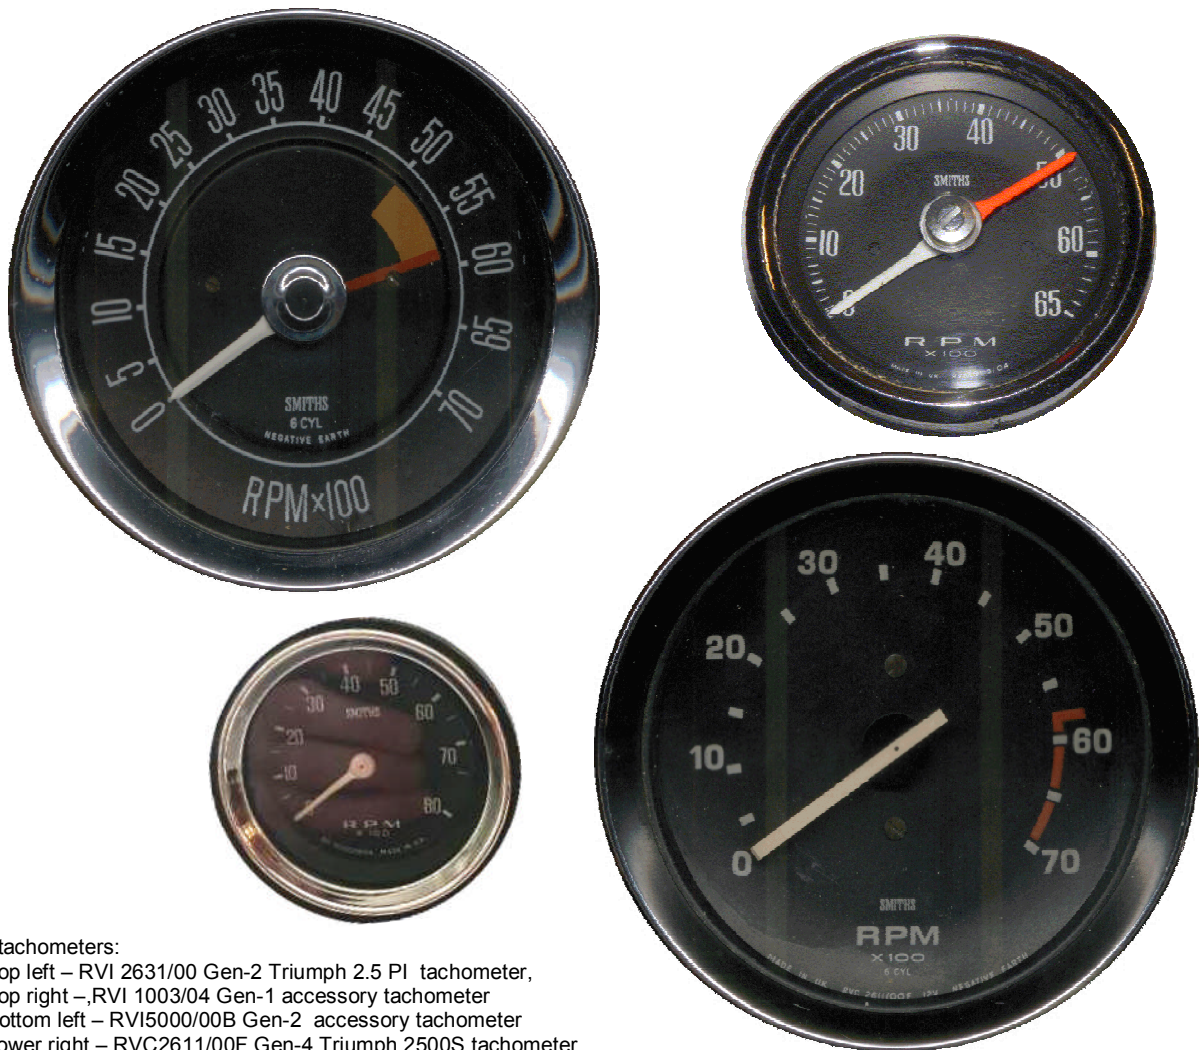
**Ttachometers:**

Top left – RVI 2631/00 Gen-2 Triumph 2.5 PI tachometer,  
Top right – RVI 1003/04 Gen-1 accessory tachometer  
Bottom left – RVI5000/00B Gen-2 accessory tachometer  
Lower right – RVC2611/00F Gen-4 Triumph 2500S tachometer

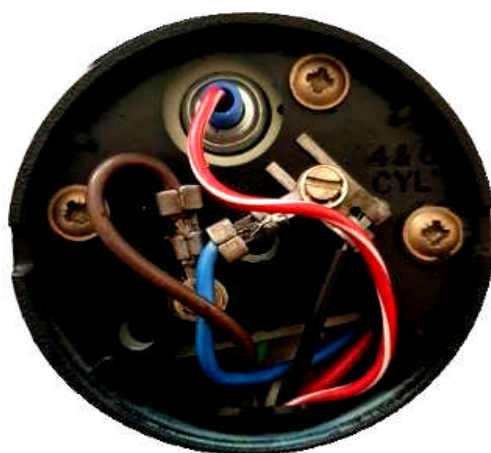
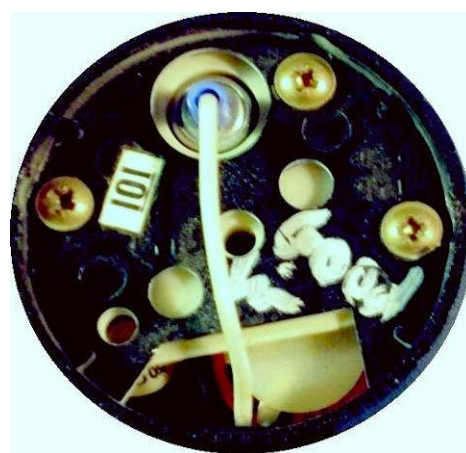
**FIGURE 4.4:** RVI 5000 series tachometer. At left is the rear view of an accessory tachometer, with the rear cover removed and showing the cylinder select terminals. **The blue wire is the -12V connection for 4 & 6 cylinder engines, the brown wire for 8 cylinders. Not, as previously written, for voltage selection!** The black wire is the lead to the vehicle's earth connection and internally connects only to the barrel of the lamp holder. Ensure that the connectors on the Blue and Brown wires do not move and short together! The internals are electrically isolated from the car and a green wire is provided as a dedicated earth for the light and is to be connected to the car's chassis.

The right-hand picture shows the same view of an OEM instrument without the cylinder select option. (*Right-hand photo supplied by Mark Olson*)

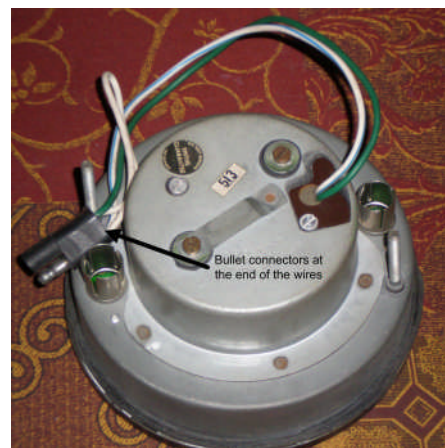
**FIGURE 6.2:** Jaguar Gen-3 RVC tachometer. Photograph courtesy of Mark Olson, Accutach.

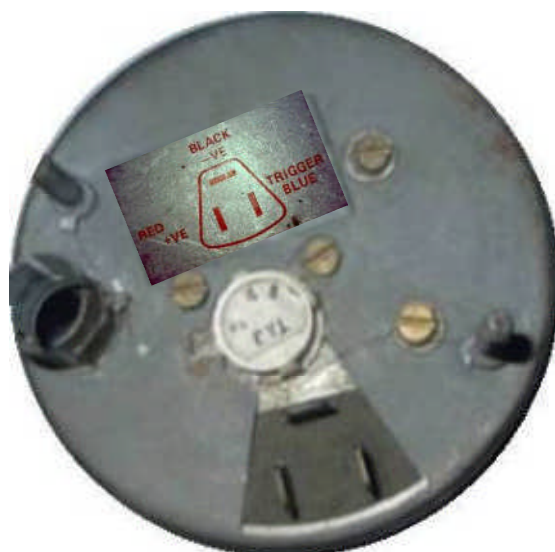
Fig. 6.5 below shows the rear of the "accessory" type Gen-4 tachometer. As with earlier accessory instruments, the electronics inside are electrically isolated from the case.

Note the white selector switch next to the terminals. This selector switch is only found on Gen-4 instruments, Gen-3 RVC tachometers used a switch accessed through a hole in the rear of the case.

**FIGURE 6.5:** Rear view of Gen-4 accessory tachometer. Terminals at bottom with white cylinder select switch above. Wiring of terminals redrawn at right.

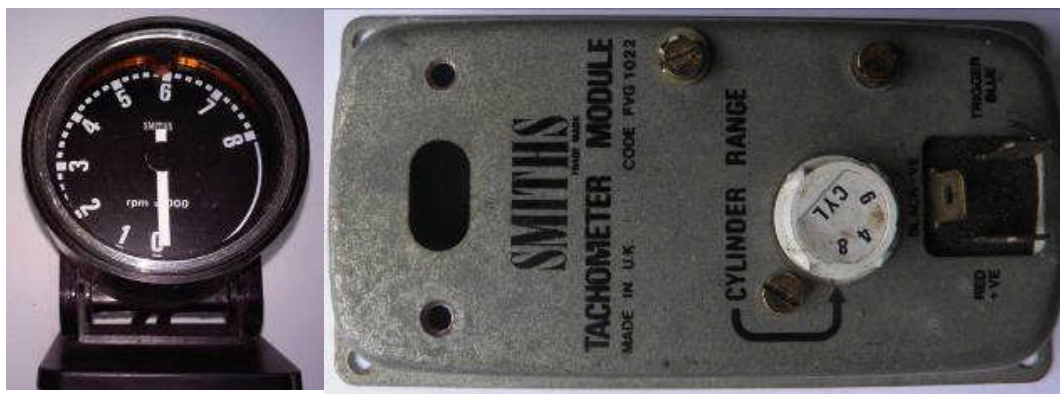
Fig.6.6 shows the RVC range's answer to the RVI 5000 series instruments. This comprises a small indicator head designed to be mounted on a dashboard with adhesive pads fitted to the base. Four wires (2 for meter, 2 for lighting) lead from the underside of the indicator head through a hole cut in the dashboard. All the electronics are housed in a rectangular metal case which is intended to be hidden behind the dashboard. Power and pulse connections are made at the electronics unit and are the same as those shown for the Gen-4 accessory tachometer above. A two-pin Cinch socket for connection to the indicator pod meter is provided and located in the hole above "SMITHS".

**FIGURE 6.6:** Gen-4 pod style tachometer comprising FVG 1021 head unit and separate FVG 1022 electronics module for mounting under dashboard.

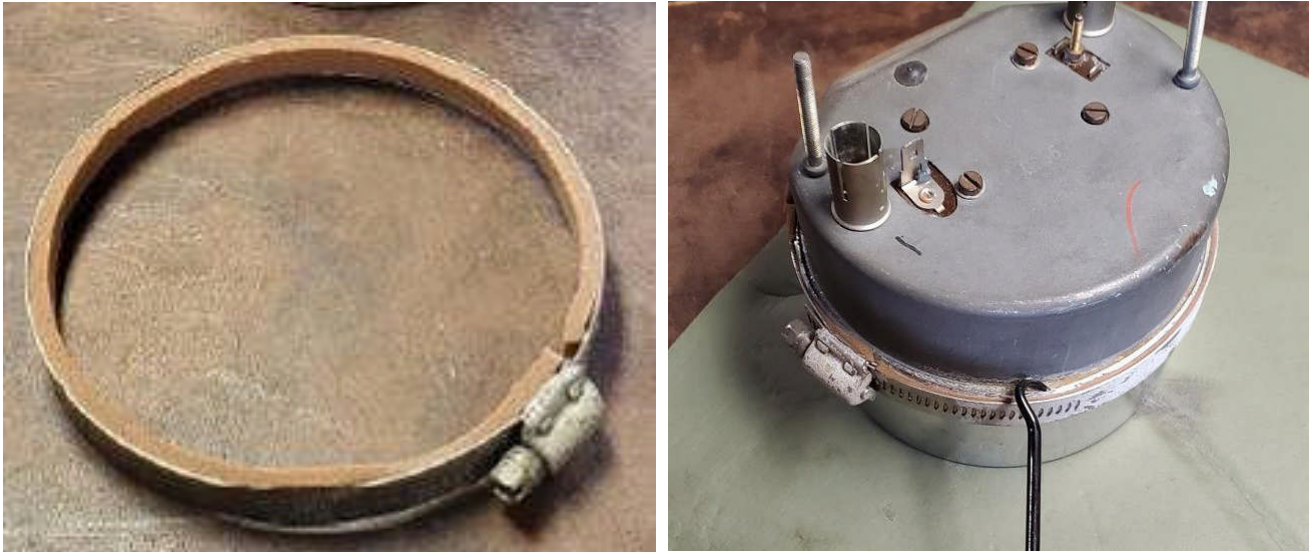
Spun-on bezels, as used on 3" instruments, are not intended to be re-used. The official Smiths method of removal is to cut the bezel around and replace with a new one. Bezels can be reused once if care is taken. Some means of supporting the rim of the bezel is required for recovery to be successful. One such tool is shown in *fig. C.1* below.

**FIGURE C.1:** Tool for removing spun-on bezel. A strip of adhesive backed foam rubber is stuck to a worm-drive hose clamp which is clamped around the rim of the bezel. The rubber is to protect the finish on the bezel itself. A blade screwdriver or similar is used to lift the spun over metal to remove the bezel. Right hand photograph shows tool fitted to a Volvo RVI 3410/00 tachometer.

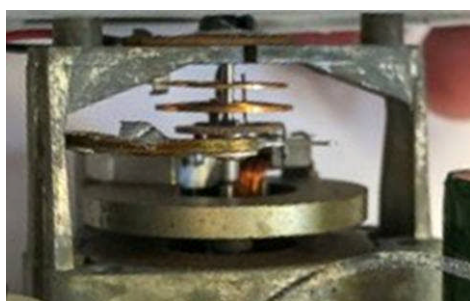
*Fig. F.2* shows the meter used in the earlier instruments. This is quite different to the later meter.

**FIGURE F.2:** Early meter assembly showing the die cast bridge that is part of the meter body casting. Circled area in right-hand picture shows solder added to the meter armature counterweight to balance the assembly.

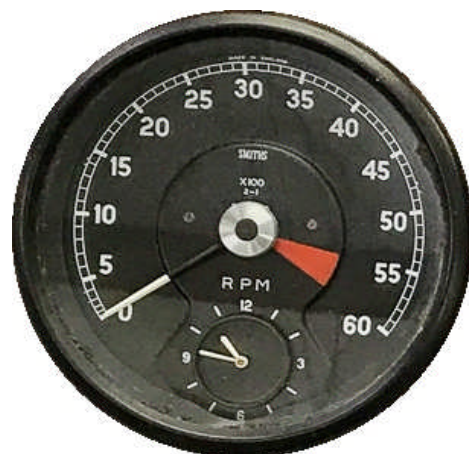
**FIGURE F.3:** Typical Smiths RV 7000 series tachometer. This one a RV 7403/00 from a 1962 Mk. II Jaguar. Photograph by Phil Turnbull, NZ
